TEST RESULTS REPORT AND DESIGN TECHNOLOGY DEVELOPMENT REPORT - HLH/ATC
HIGH-SPEED TAPERED ROLLER BEARING
DEVELOPMENT PROGRAM

Boeing Vertol Company

Army Air Mobility Laboratory

June 1974

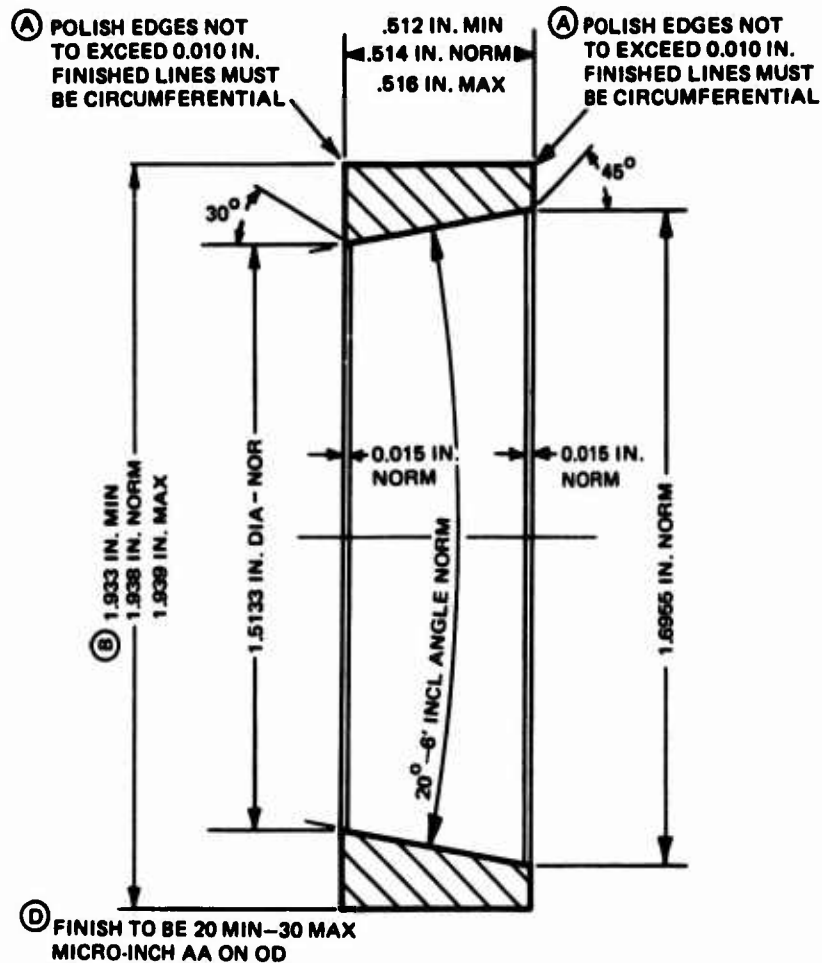
Figure 4. Test Cup for Timken Lubricant and Wear Test Machine.

Various wear-resistant materials were evaluated in the Timken lubricant and wear test machine. The machine requires test cages as shown in Figure 4 and test blocks as shown in Figure 5 to conduct these tests. The following material specimens were evaluated:

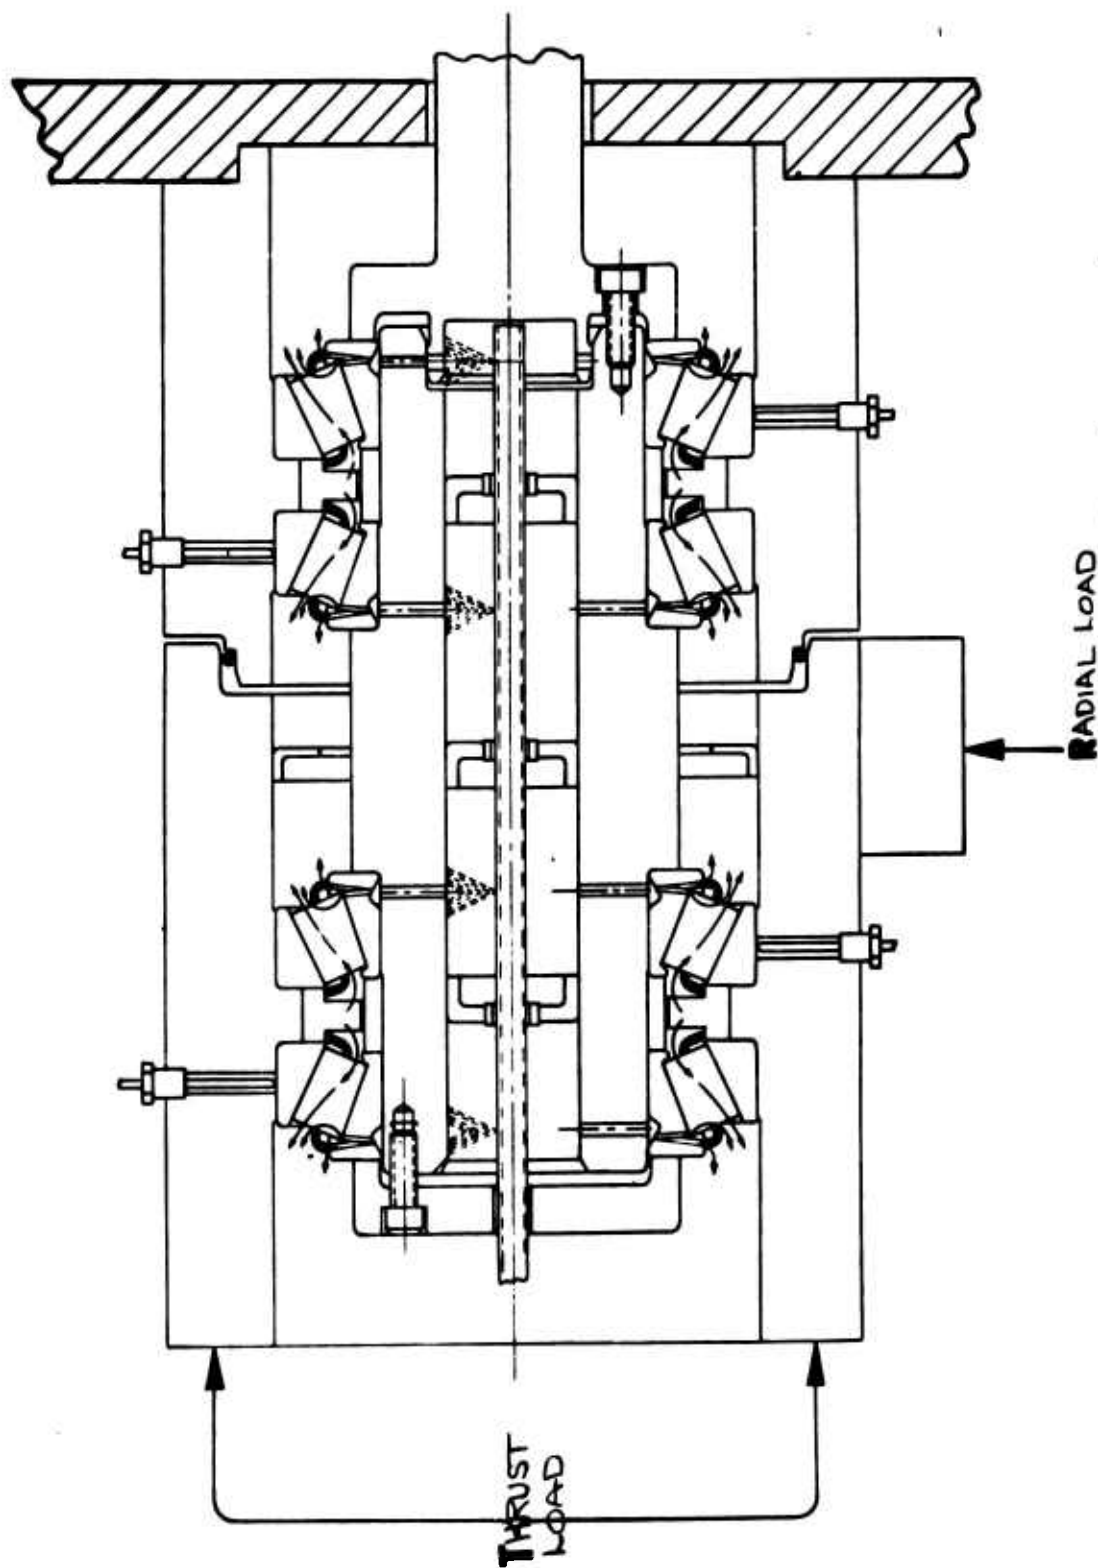
Figure 18. Schematic of HLH Test Machine Showing Bearing Mounting, Loading, and Lubrication System.

Figure 18 shows bearing mounting, and loading and lubrication systems. The bearing mounting arrangement simulates the mounting arrangement in the HLH combining transmission input bevel pinion gear.

The manifold projecting into the hollow shaft discharges oil through orifices located axially in line with the radial holes in the shaft. There are two 3/16-inch radial holes through the shaft at each bearing position. The dams located between each bearing position along the length of the shafts assure an equal distribution of lubricating oil to the four bearings. The cone bore manifold then collects the oil and distributes it to the radial holes in the cone to lubricate the cone rib and roller ends. Three 0.060-inch jets located at the small end of the bearing, 120 degrees apart, discharge the oil underneath the cage to lubricate the cage roller body contact and inner and outer race. The oil-flow rate supplied to each bearing was calibrated by collecting the oil with a graduated measuring cup, while being timed with a stop watch. The oil flow rate was recorded on an Esterline-Angus multipoint strip chart recorder. In addition, each orifice on the manifold projecting into the hollow shaft was sized and calibrated to assure an equal amount of oil supplied to each bearing.

The bearing lubrication system is equipped with a stainless steel heat exchanger to control the inlet oil temperature at a

given value and with flow controls capable of maintaining any desired flow rate up to 16 pints per minute per bearing (oil inlet temperature at 190°F).

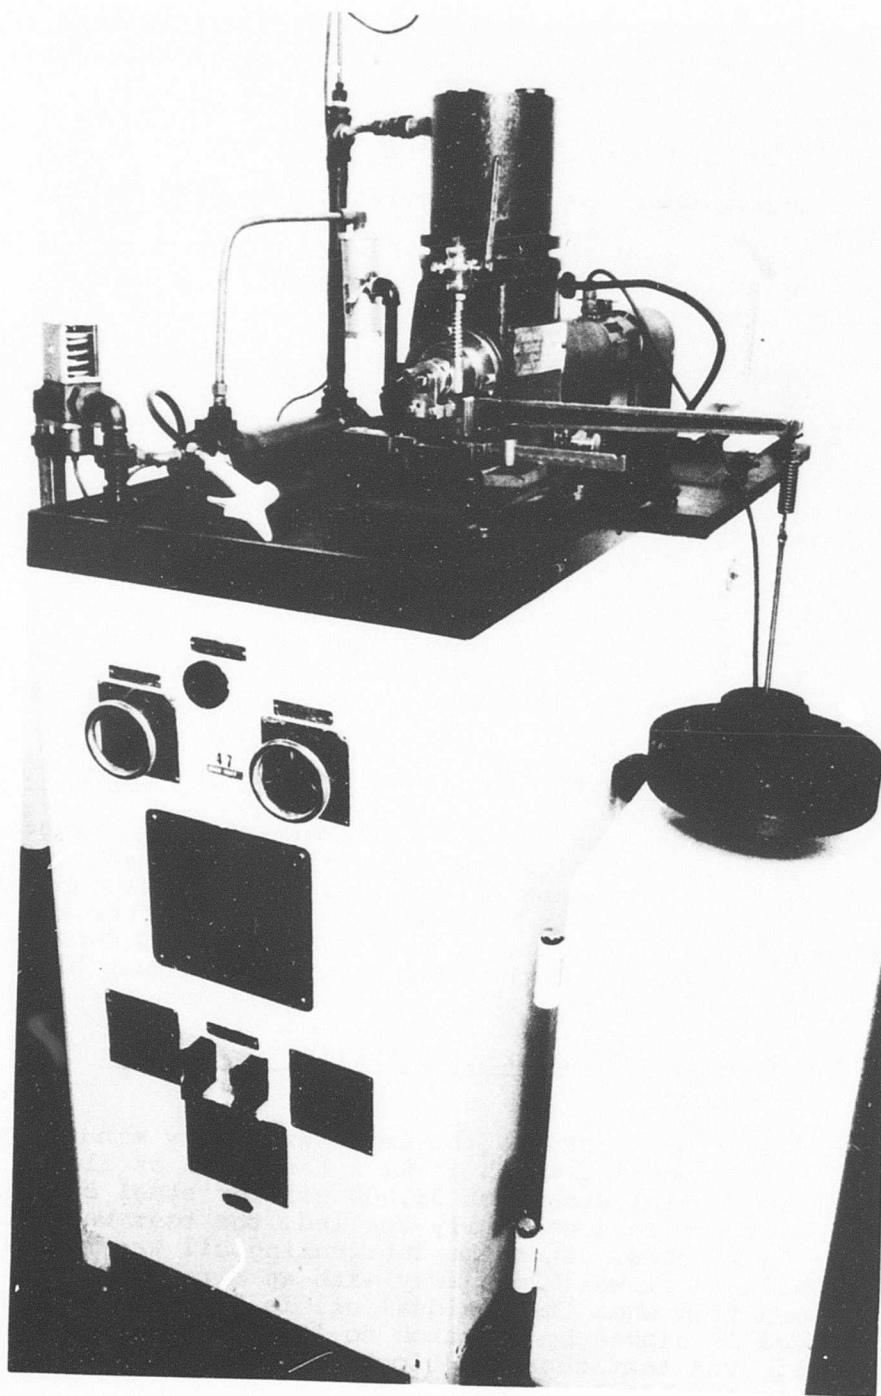
Figure 19. Timken Lubricant and Wear Test Machine.

Various fail-safe wear-resistant materials were evaluated in the Timken Lubricant and Wear Test Machine. This test machine is used in ASTM Standard D2782-71, standard method for "Measurement of Extreme Pressure Properties of Lubricating Methods (Timken Method)."

A 1-pound weight was added to the lever arm every minute up to a total of 10 pounds, which gives a test load of 116.6 pounds and an initial stress of 36,000 psi for steel cups and blocks. After the load was fully applied, the test was run an additional 10 minutes. Then the lubricating oil was shut off and the residual oil was blown away with an air hose. The test is timed from when the residual oil is blown away until the cup speed is slowed by friction to 1000 rpm (507.4 feet per minute). The test cups and blocks were reweighed, and the scar width on the block was measured.

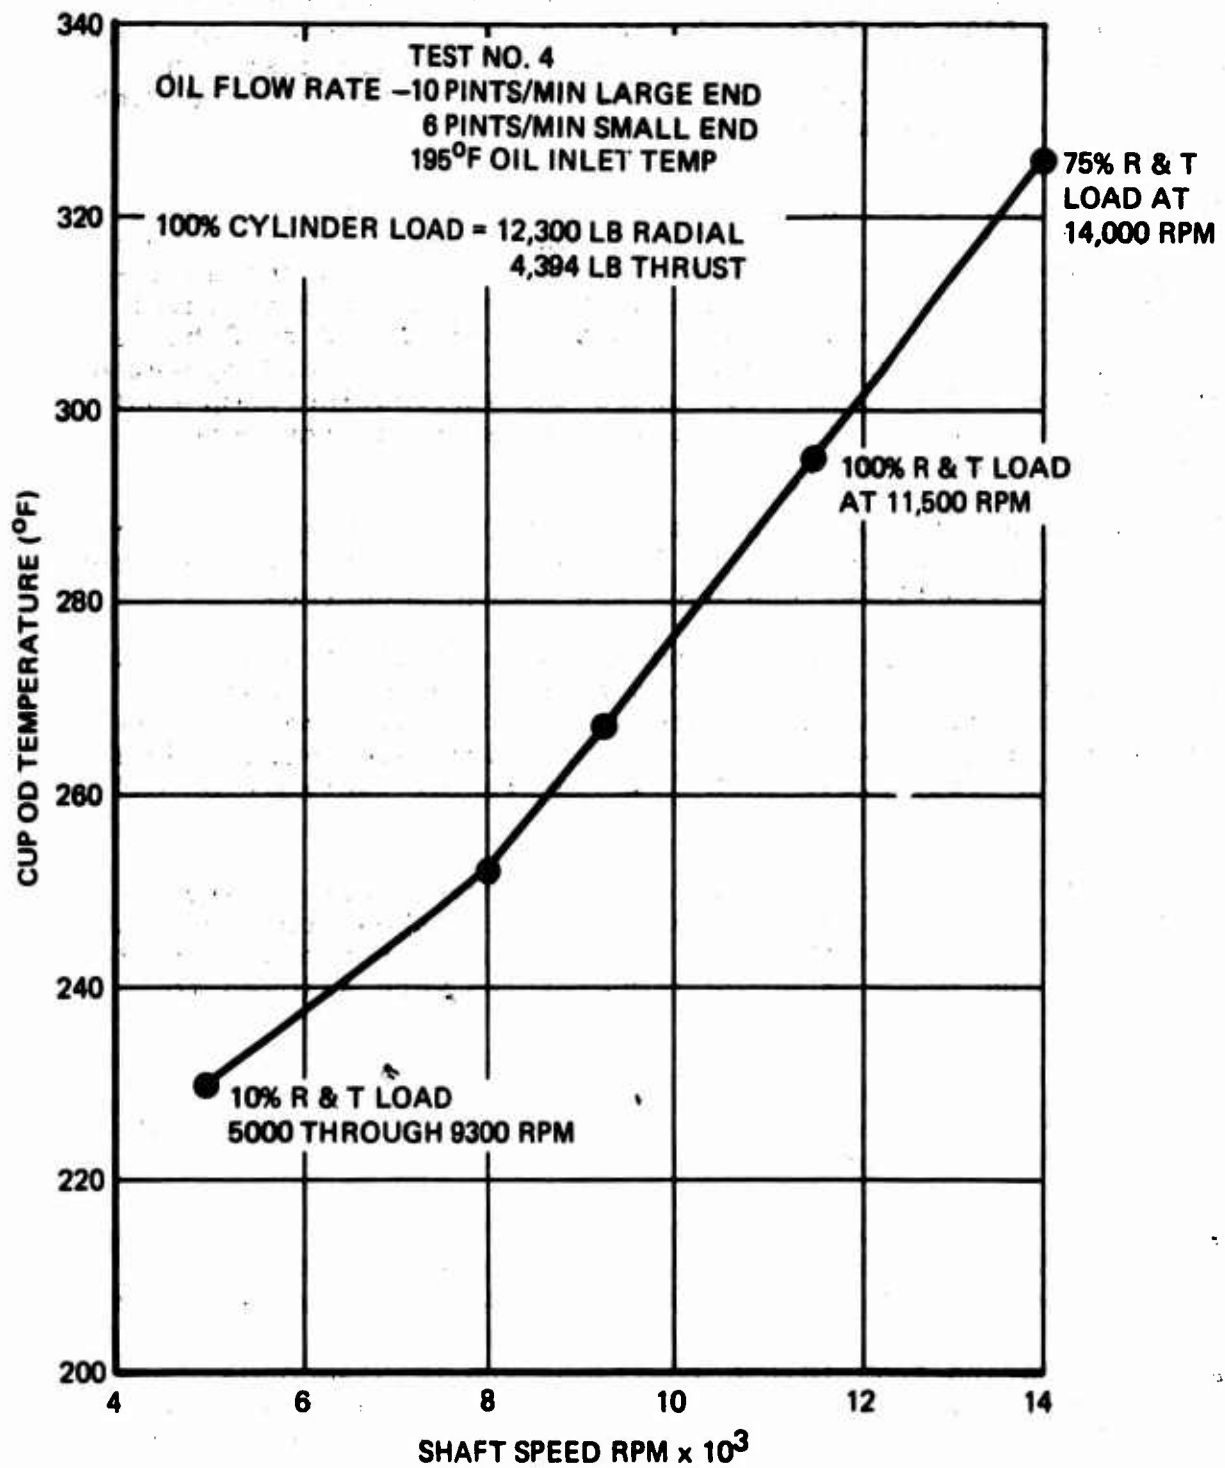
Figure 30. HM926700-Series Bearing Cup OD Temperature Versus RPM.

- Accelerating from 0 to 10,000 rpm in less than 30 seconds and running for 5 minutes under 10-percent load (applied cylinder load of 1230 pounds radial and 440 pounds thrust).
- Accelerating from 10,000 to 11,500 rpm in 5 seconds, increasing load to 100 percent (12,300 pounds radial and 4394 pounds thrust applied cylinder load) and letting it run for 5 minutes.

- Reducing the load to 75 percent of the applied radial and thrust loads and accelerating from 11,500 to 14,000 rpm in 5 seconds. The acceleration runs were started with both room temperature and preheated lubricating oil, and also with both oil pumps on first. The drive system and simultaneous oil pump-drive system then starts.

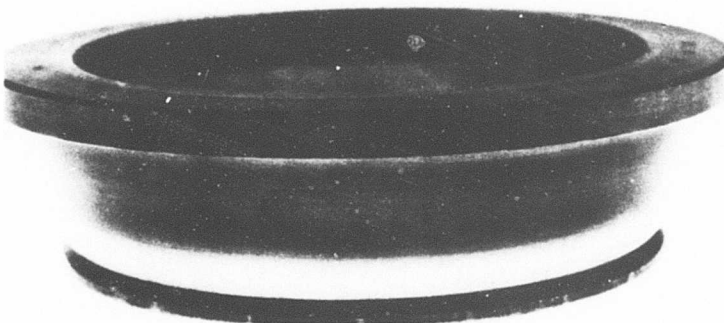
Figure 31. HM926700-Series Bearing Cones From Test Number 4.

NOTE: SMALL SPALLS APPEARED AFTER 36 HOURS AT 14,000 rpm
UNDER FULL RADIAL AND THRUST LOAD

Five microhardness measurements between the surface and a depth of 0.038 inch below the surface were taken near the middle of the discolored area. They were 55.5 Rockwell "C", 55.0 Rockwell "C", 54.5 Rockwell "C", 56.0 Rockwell "C", and 55.0 Rockwell "C" with Knoop converted to Rockwell "C".

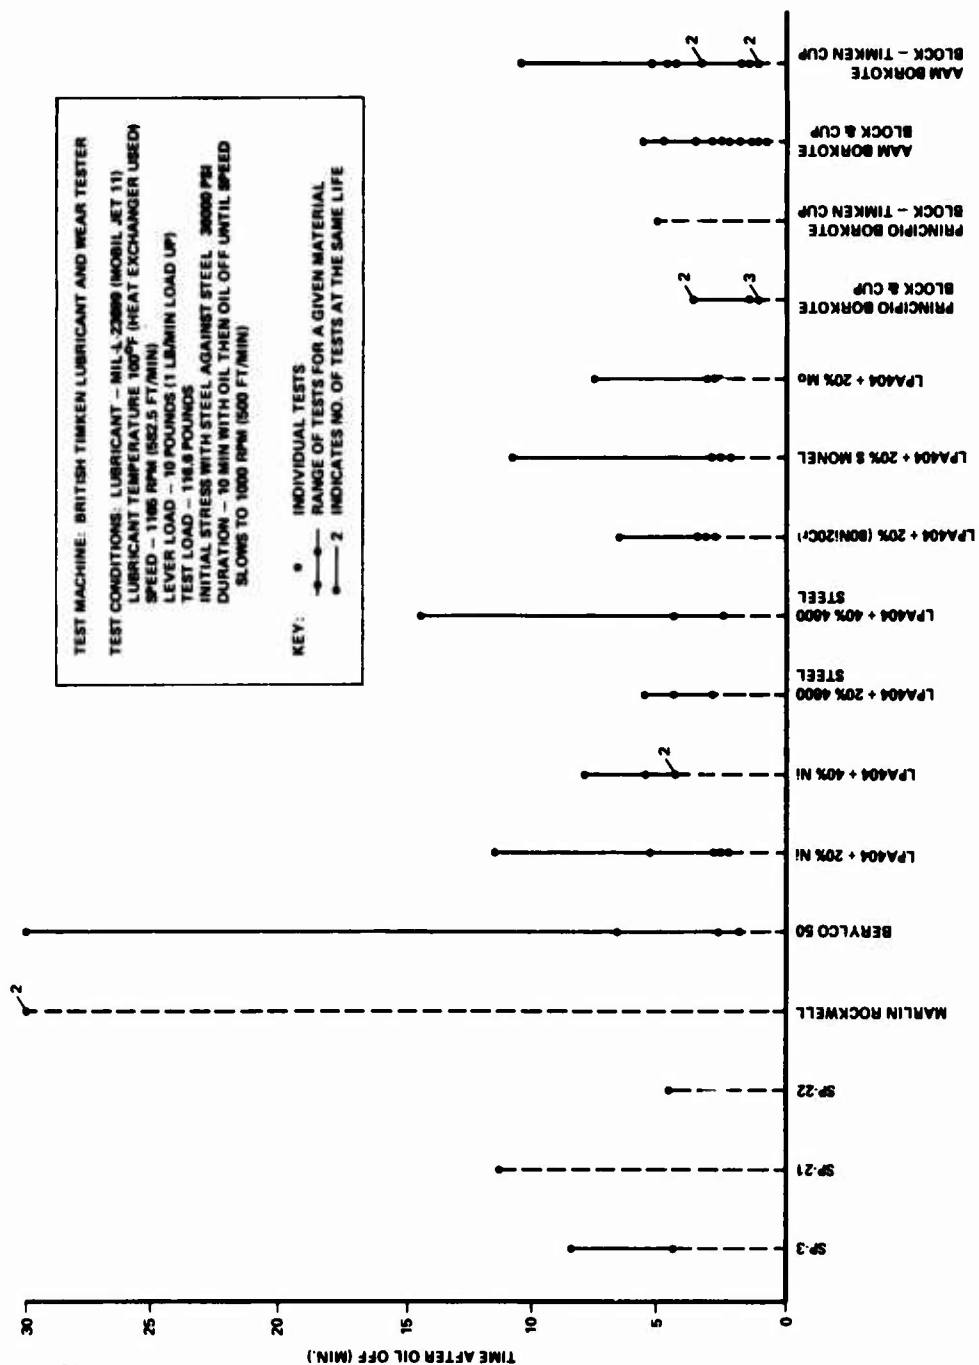
Figure 33. Comparison of Materials Considered for Use in the Fail-Safe Bearing Test Program.

The DuPont Vespel and Marlin-Rockwell materials gave a good life in oil-off testing, but had a considerable amount of wear.

Beryllium copper material had a good life with fair wear.

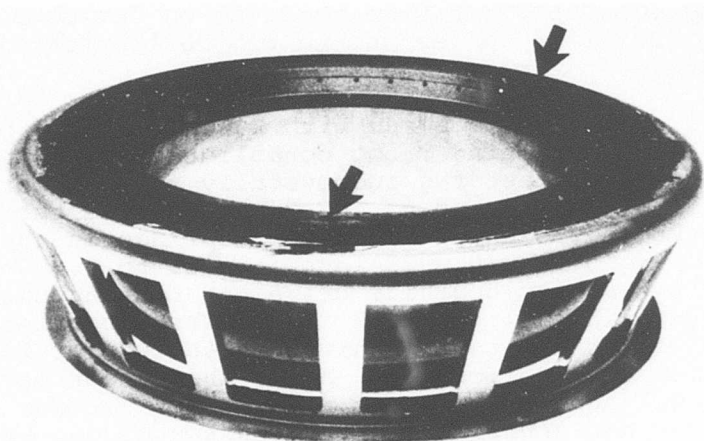
Figure 36. Cracking of Borkote Rib Flange.

The fourth fail-safe test was run with bearings identical to the third test. This test was to be an extended 150-hour test with lubricating oil and measuring end-play at specified intervals. The end-play at the end of 24 hours did not change from the initial end-play of 0.0025-inch in the drive end housing and 0.005-inch in the opposite drive end housing. Cone

rib/roller end scuffing damage occurred at 50.5 hours, running at 11,500 rpm with oil lubrication.

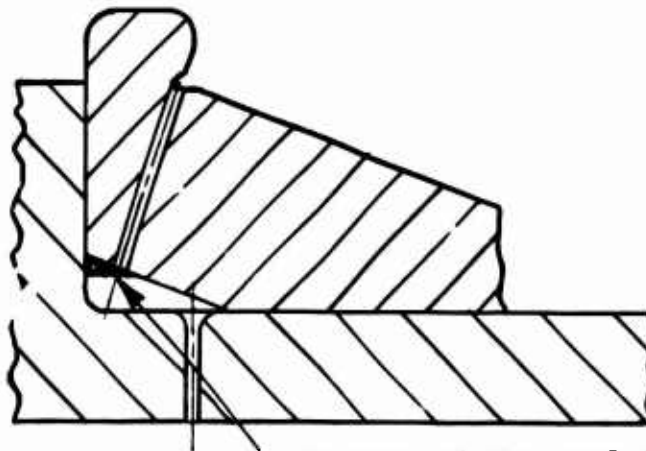
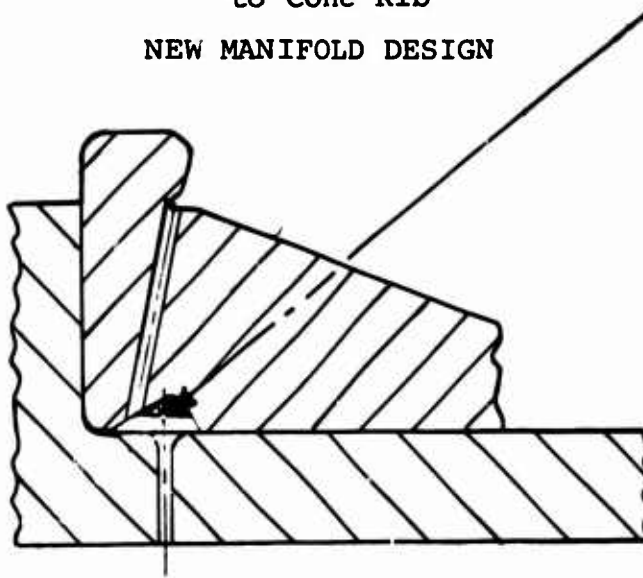
Figure 39. Old and New Type Cone Bore Manifold Design.

OLD MANIFOLD DESIGN

Spillover of Trapped Oil
Here Used to Provide Equal
Distribution to All Holes
to Cone Rib

NEW MANIFOLD DESIGN

This Design Prevents Leakage
Between Cone Backface and
Cone Backing

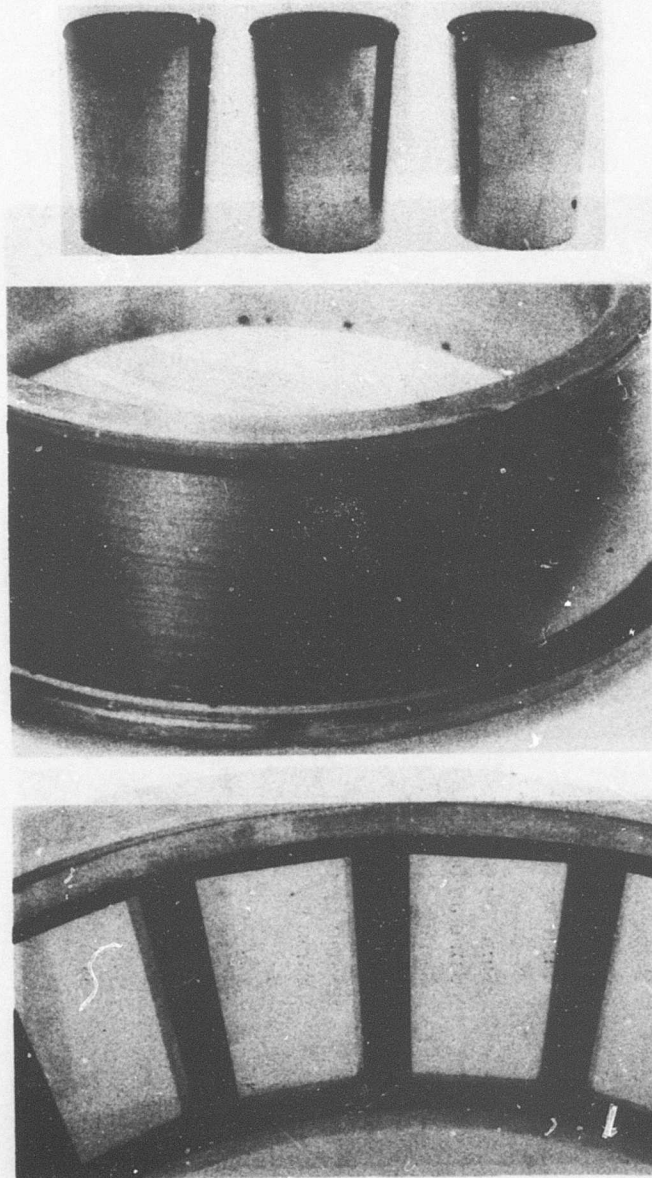
CONE HAS 17 RADIAL OIL LUBRICATION HOLES.

Figure 44. HM926700-Series Bearing After Test, Bearing No. 60-1,
Test No. 1--Damaged After Running $1\frac{1}{2}$ Minutes at 9300rpm.

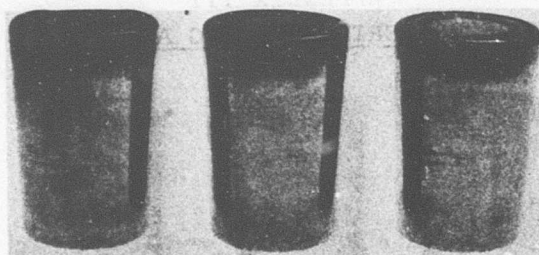
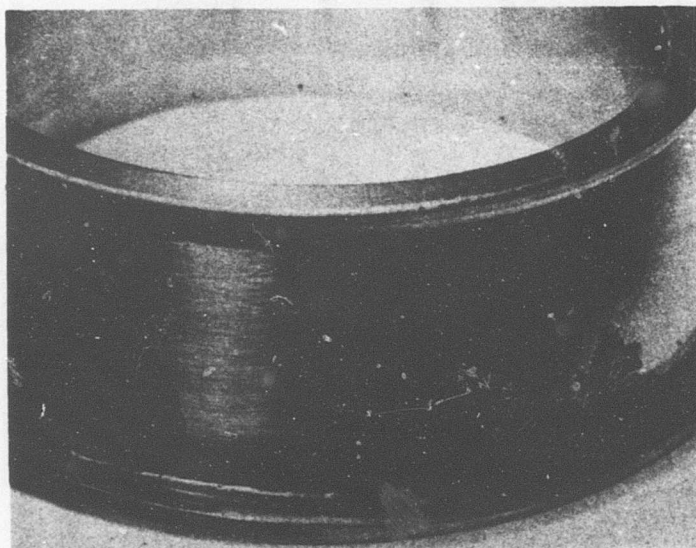
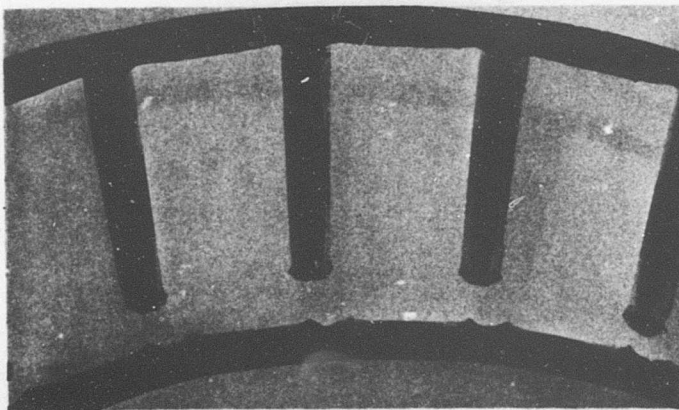
Figure 45. HM926700-Series Bearing After Test, Bearing No. 60-4, Test No. 2--Damaged After Running for 45 Minutes at 14,000 rpm.

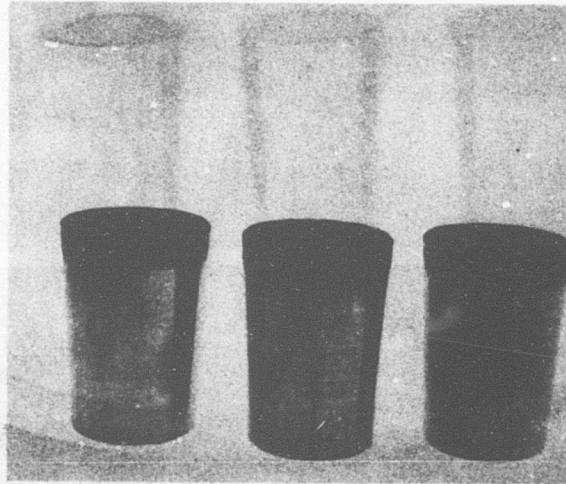
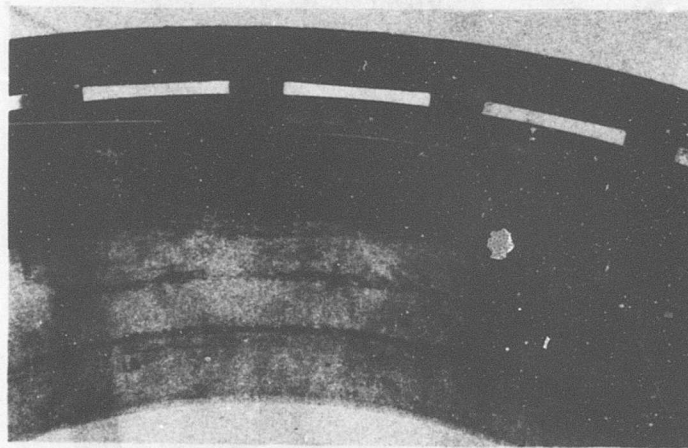
NOTE: CONE HAS 17 RADIAL OIL LUBRICATION HOLES

Figure 46. HM926700-Series Bearing After Test, Bearing No. 60-4A, Test No. 3--Damaged After Running 3 Minutes at 14,000 rpm.

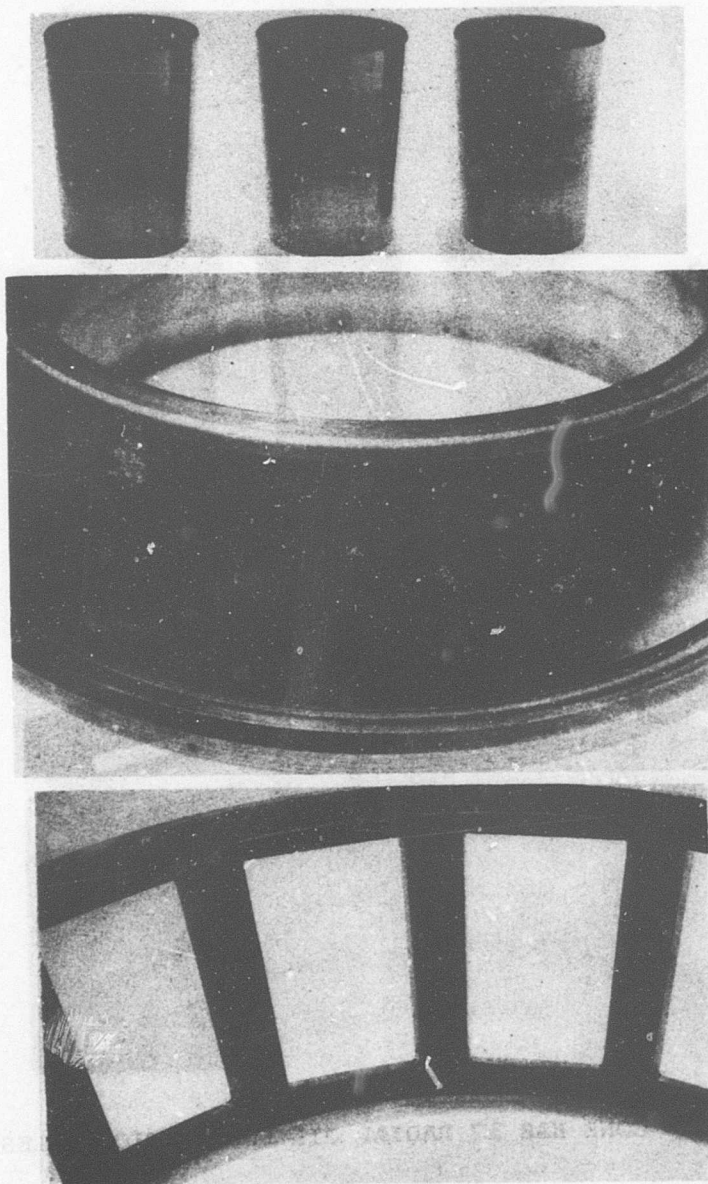
NOTE: CONE HAS 17 RADIAL OIL LUBE HOLES

Figure 47. HM926700-Series Bearing After Test, Bearing No. 60-7, Test No. 3--Okay After Running at 14,000 rpm for 3 Minutes.

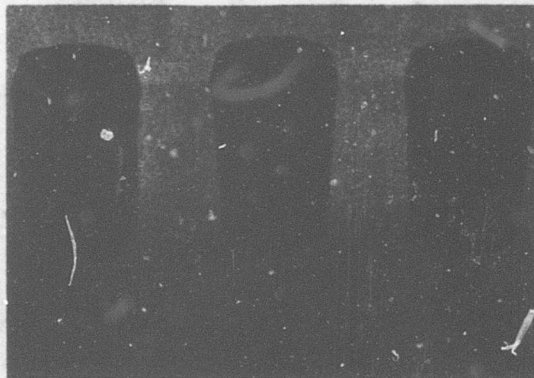
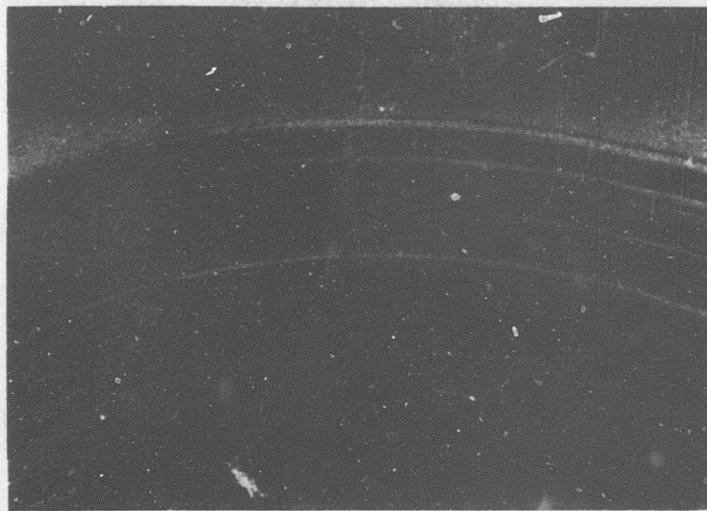
Figure 49. HM926700-Series Bearing After Test, Bearing
No. 3, Test No. 11--Damaged While Accelerating
to 9000 rpm.

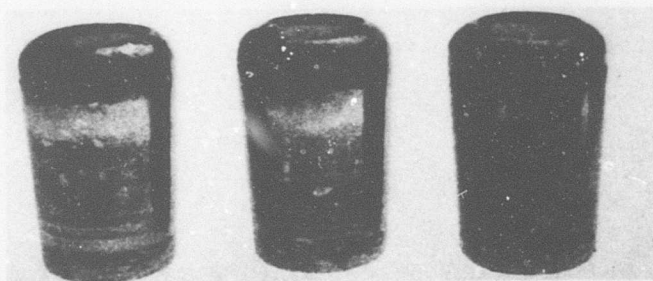
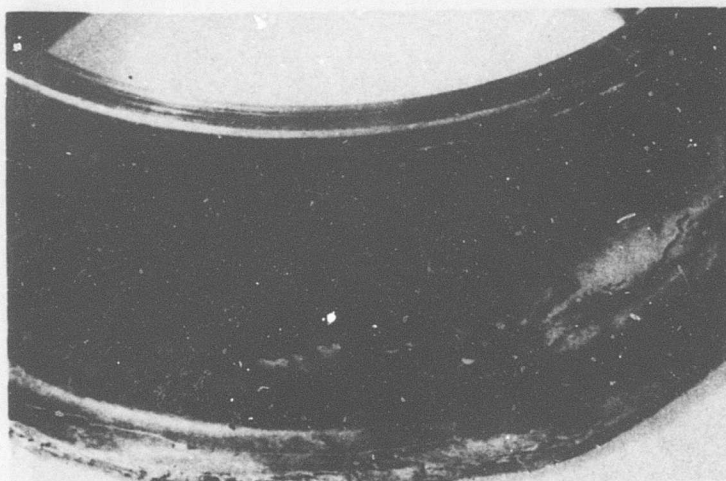
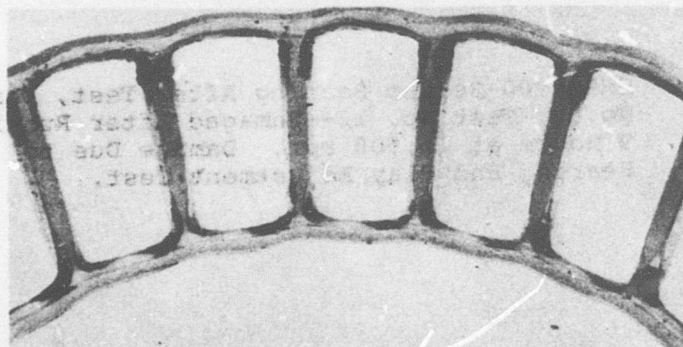
Figure 50. HM926700-Series Bearing After Test, Bearing No. 7, Test Nos. 12 through 17--Damaged After 22 hours at 11,500 rpm.

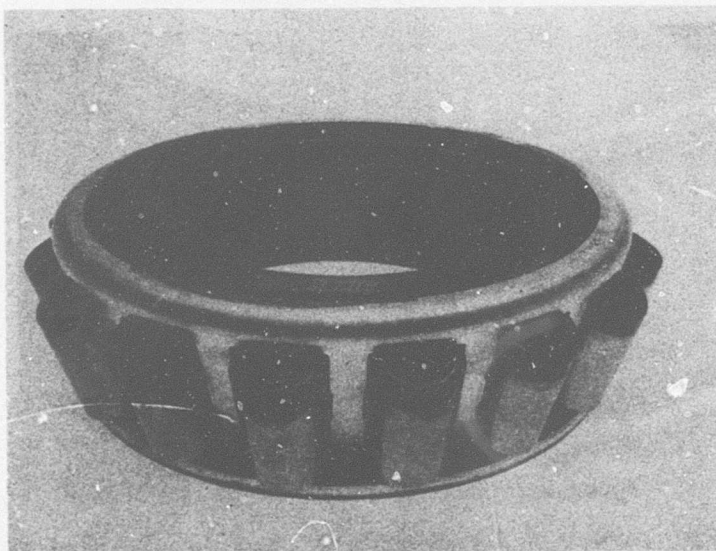
Figure 51. HM926700-Series Bearing After Test, Bearing No. 8, Test No. 12--Damaged After Running 9 Hours at 11,500 rpm. Damage Due to Bearing End-Play Adjustment Test.

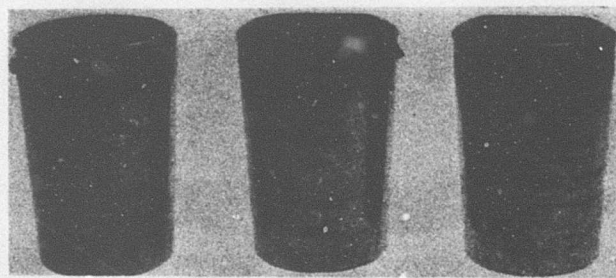
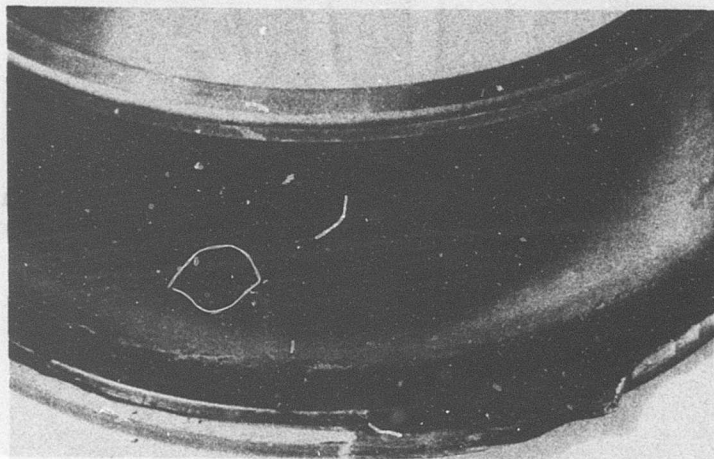
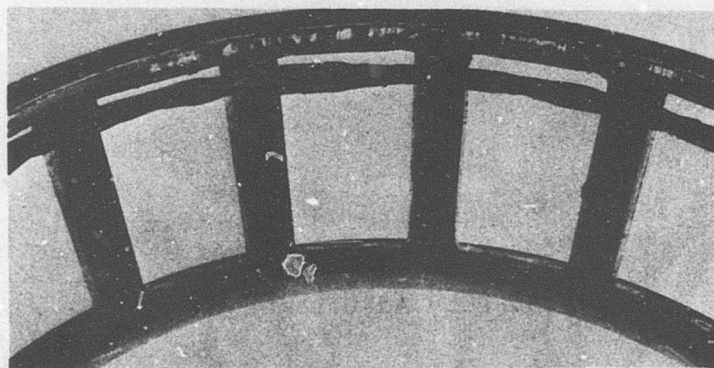
Figure 52. HM926700-Series Bearing After Test, Bearing No. 6, Test No. 13--Damaged After Running for 13 Hours at 11,500 rpm With Various Bearing End-Play Adjustments.

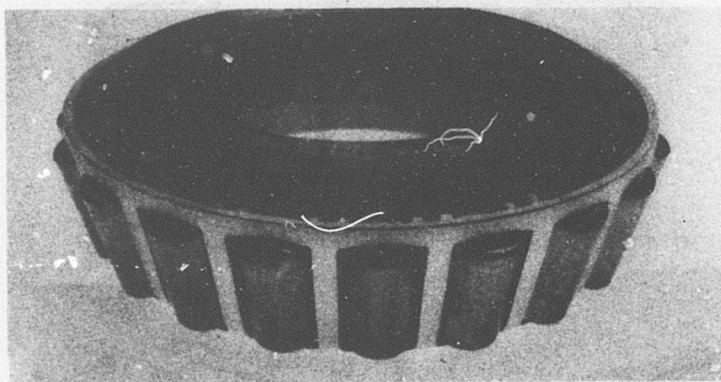
Figure 53. HM926700-Series Bearing After Test, Bearing No. 9--Okay After Running in Test Numbers 13 Through 17 and Test No. 21.

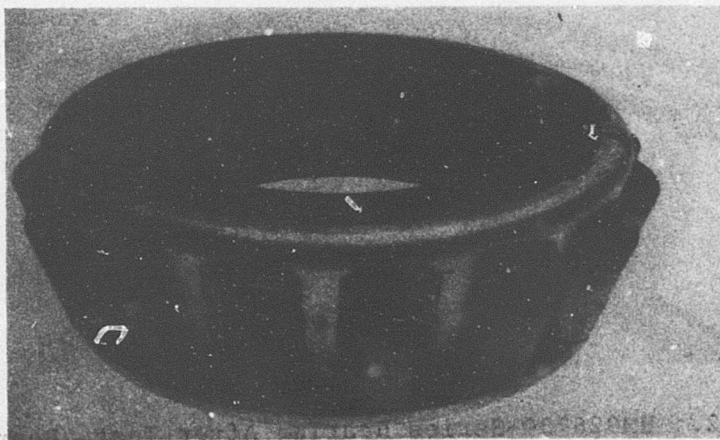
Test numbers 14 and 15 had premature bearing damage due to test assembly problems. In test number 14, a Z-type cage was

unknowingly bent on assembly, causing early bearing damage. In test number 15, the drive spindle was assembled to the test shaft in such a way that it would not permit the lubricating oil from the center of the shaft to reach the drive end bearing.

Figure 54. HM926700-Series Bearing After Test, Bearing No. 10, Test No. 15--Damaged Due to Test Assembly Problem.

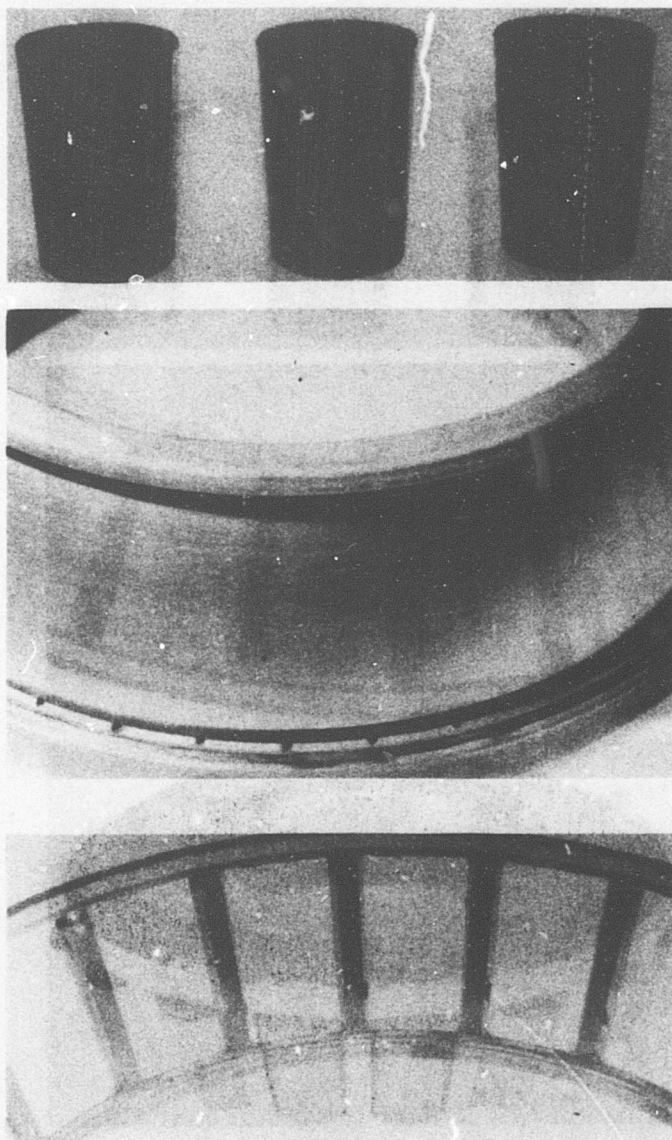
Figure 55. HM926700-Series Bearing After Test, Bearing No. T-8, Test No. 22--Damaged After Running 9 Hours at 11,500 rpm. Damage Due to Bearing End-Play Adjustment Test.

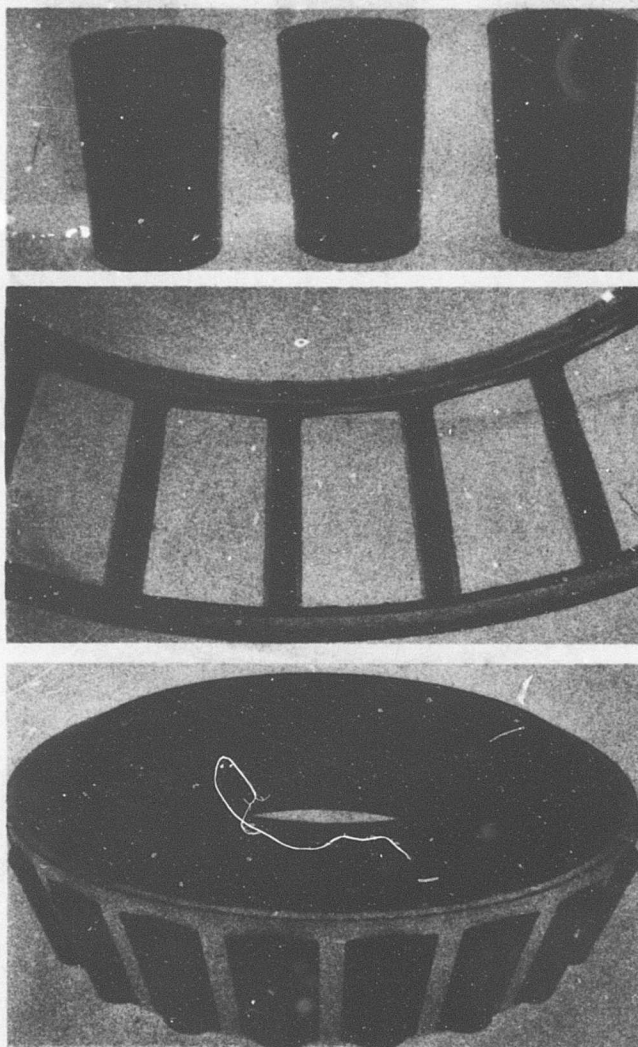
Figure 56. HM926700-Series Bearing After Test, Bearing No. T-6, Test No. 23--Damaged While Accelerating to 10,000 rpm.

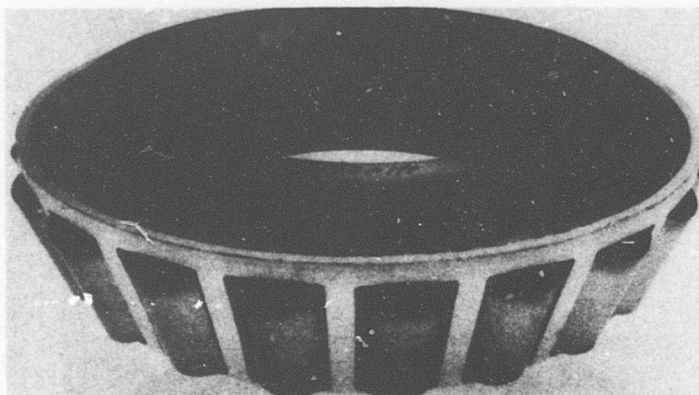
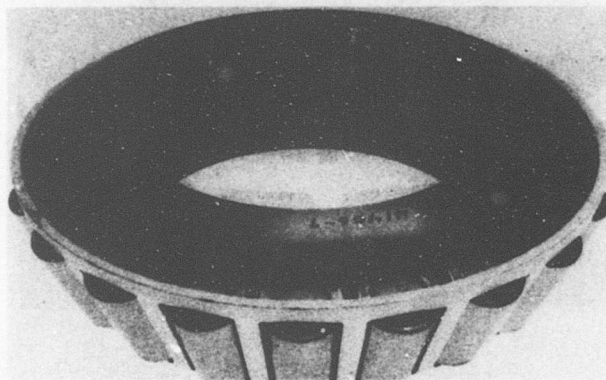
Figure 57. HM926700-Series Bearings After Test, Bearing Numbers T-7 and T-9, Test No. 24--Damaged at 11,500 rpm.

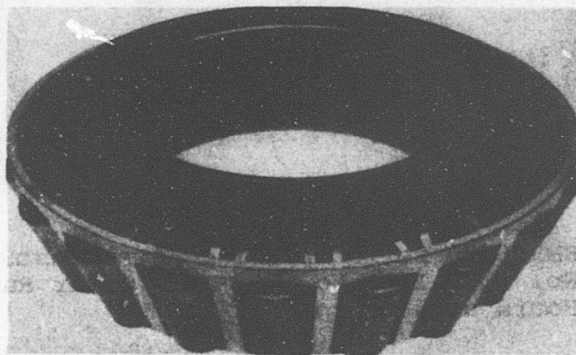
Figure 58. HM926700-Series Bearing After Test, Bearing No. T-10--Okay After Running in Test No. 24.

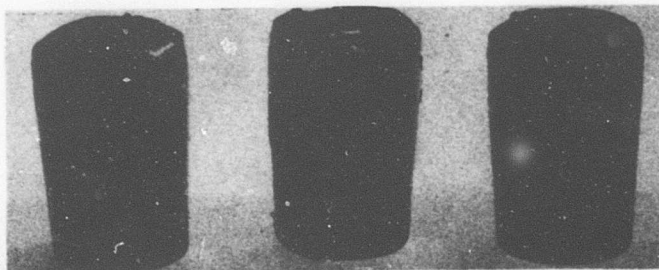
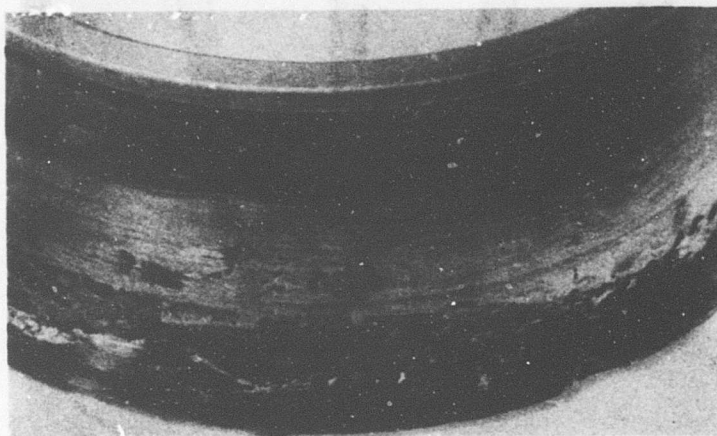
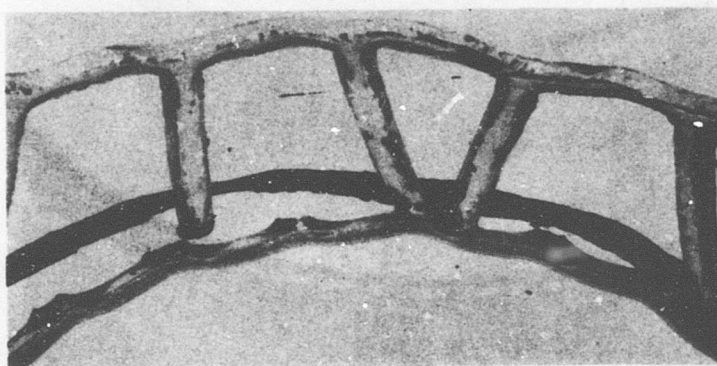
Figure 60. HM926700-Series Bearing After Test, Bearing No. T-14, Test No. 27--Damaged After Running 1 Hour at 11,500 rpm.

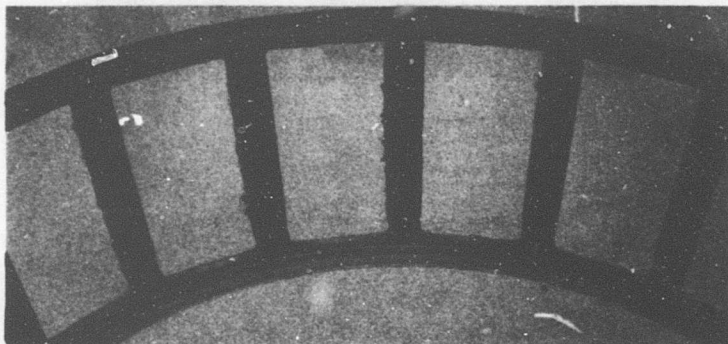
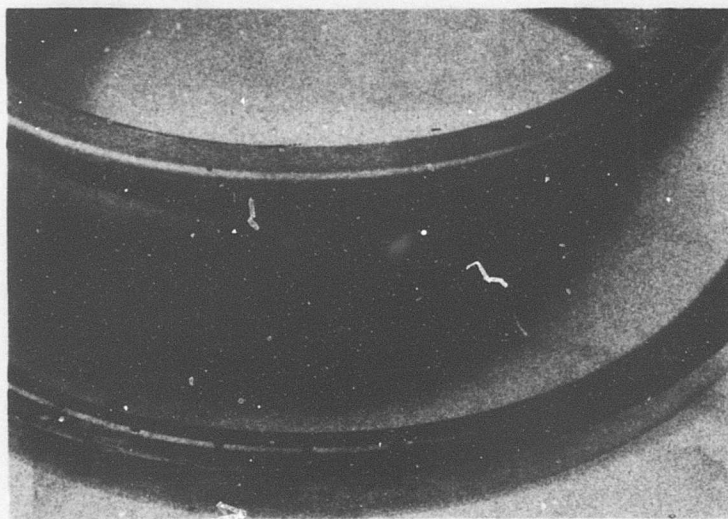
**Figure 61. HM926700-Series Bearing After Test, Bearing
No. 73-5, Test No. 29--Damaged at 10,000 rpm.**

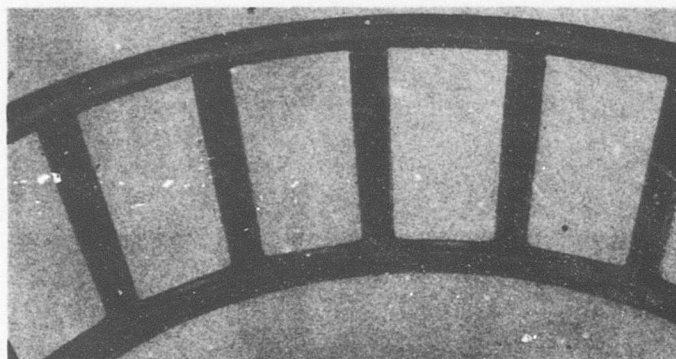
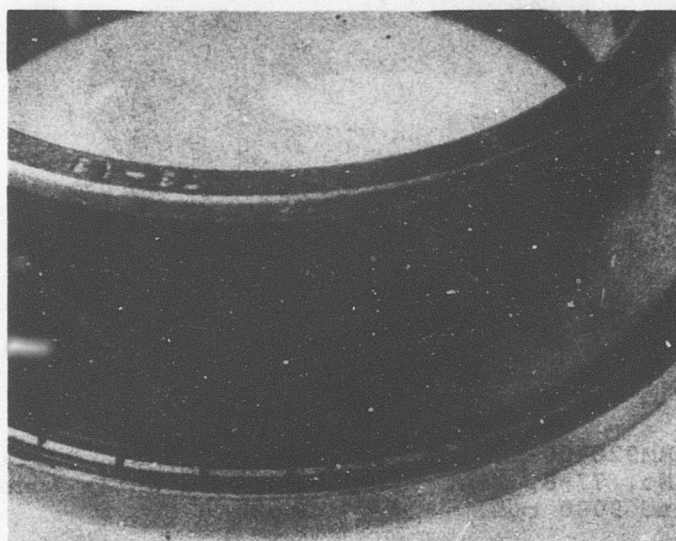
Figure 62. HM926700-Series Bearing After Test, Bearing No. 73-13, Test Numbers 31 Through 33--Okay After Running 24 Minutes at 11,500 rpm.

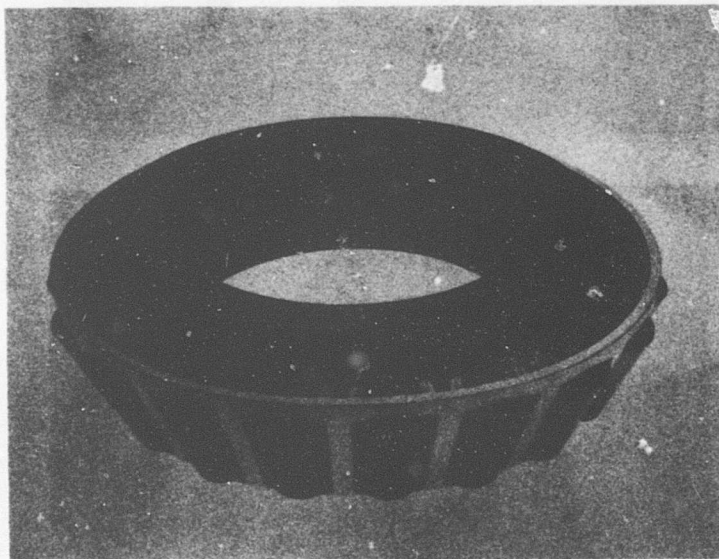
Figure 63. HM926700-Series Bearing After Test, Bearing No. 73-8, Test No. 33--Damaged While Accelerating to 9000 rpm.

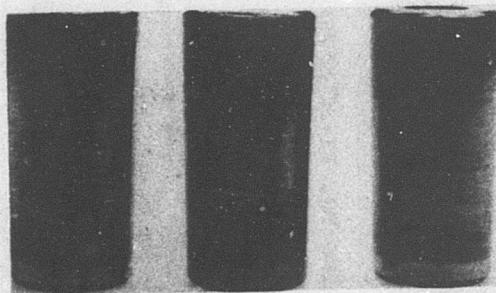
CHIPPED CONE RIB OCCURRED WHEN CAGE WAS REMOVED FROM CONE

Figure 64. XC11439-Series Bearing After Test, Bearing No. 73-65, Test No. 5--Damaged Due to Large Sheets of Silver Plating Separating From the Cage.

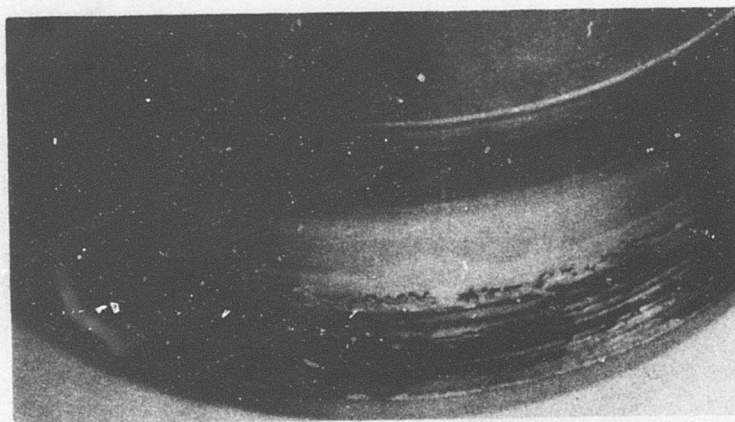
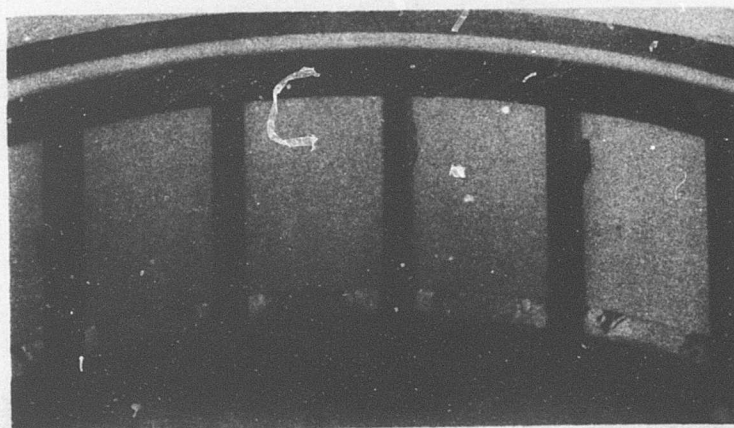
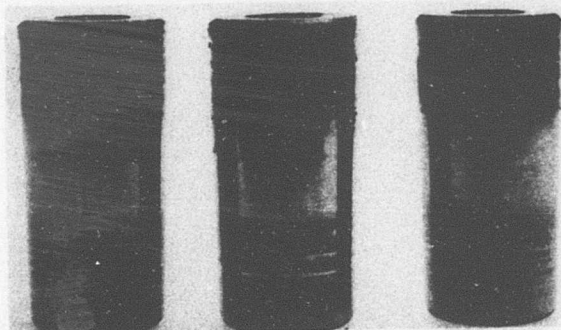
Figure 66. XC11439-Series Bearing After Test, Bearing No. 73-49, Test No. 3--Damaged Due to Insufficient Bearing End-Play Adjustment.

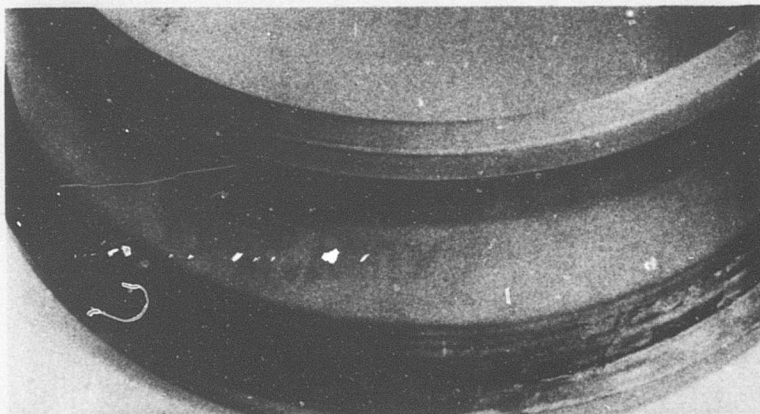
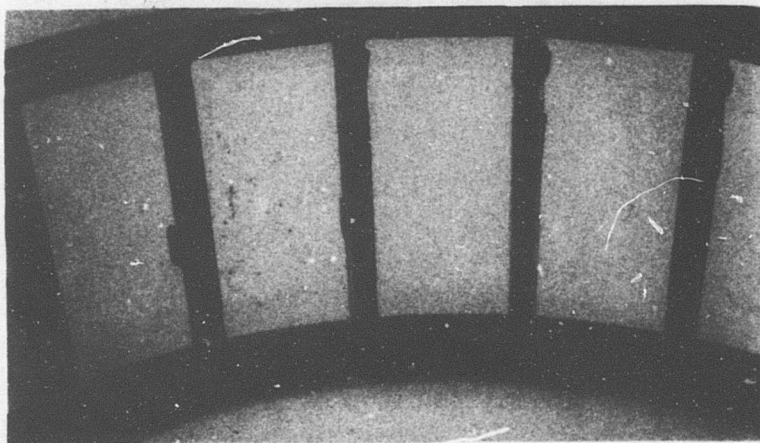
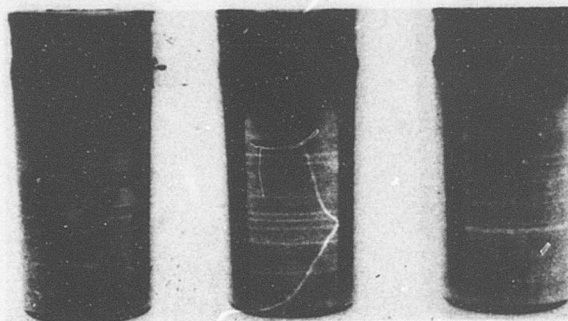
Figure 67. XC11439-Series Bearing After Test, Bearing No. 73, Test No. 6--Damaged Due to Lubricating Oil Pump Shutdown After Running 45 Minutes at 11,500 rpm.
